## HIGH CYCLE FATIGUE PROPERTIES OF AS-BUILT Ti6Al4V (ELI) PRODUCED BY DIRECT METAL LASER SINTERING

Presented at the 18<sup>th</sup> Annual International RAPDASA conference held from 8-10 November 2017 in Durban, South Africa

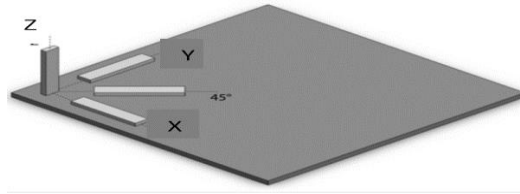
Figure 1: Illustration of a DMLS machine's base plate with rectangular specimens built in the X-, Y-, 45-, and Z-build directions

Thirty rectangular bars of width ( $W$ ) = 11 mm, height ( $H$ ) = 11 mm, and length ( $L$ ) = 60 mm were manufactured using an EOSINT M 280 DMLS machine set to the standard parameters of the supplier. Figure 2 shows the DMLS build platform, with four rectangular bars representing the four build directions with reference to the re-coater arm movement. In this study, test specimens were built along the X-, Y- and Z-build directions. For the X-build direction, the length of the bar is built parallel to the re-coater arm movement in the X-Y plane. For the Y-build direction the bar length is built perpendicular to the re-coater movement in the X-Y plane, and for the Z-direction the length is built vertical to the X-Y plane. A total of 30 rectangular bars were built: samples 1-10 in the X direction, samples 11-20 in the Y direction, and samples 21-30 in the Z direction.

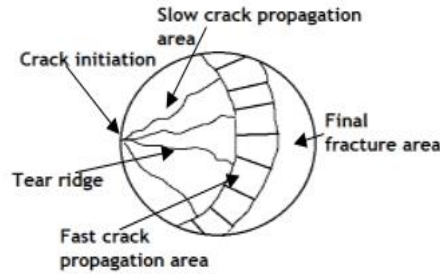
Figure 2: Schematic representation of SLM Ti6Al4V (ELI) fractograph features

The fractured specimens were analysed in a scanning electron microscope (SEM); all showed features similar to those shown in the schematic in Figure 3, which is typical of metal, and in particular of Ti6Al4V fatigue fracture surfaces [14, 15, 16]. All the fractographs showed areas of crack initiation, slow crack propagation, fast crack propagation, and final fracture. The fatigue cracks of all the fractured specimens initiated either from a surface or sub-surface micro-pore related to the DMLS

process. From this micro-pore, the fatigue failure crack propagated at a stable rate over an area that exhibited bright river-like tear ridges. The tear ridges originated from the micro-pore crack initiation sites, and spread out to the stable crack propagation (slow crack propagation) area. Their elevation increased with depth into the stable crack propagation area. This is evident from the fading of the tear ridges with movement towards the immediate area around the micro-pore crack initiation site, as seen in the overall fractographs of the specimens. Fatigue striations were located on the faces of the tear ridges on some specimens, and were oriented perpendicular to the directions of crack propagation. This signifies a bow-out (retreat) of the crack from the crack initiation sites, as observed by Joshi [17] and Milella [18]. The tear ridges died out at the overload zone, an area of unstable crack propagation (fast crack propagation). In this area, crack propagation is consistent with that of a monotonic loading, and is characterised by shallow dimples. After the unstable crack propagation area, the crack reaches a plastic area in which the specimen finally shears.

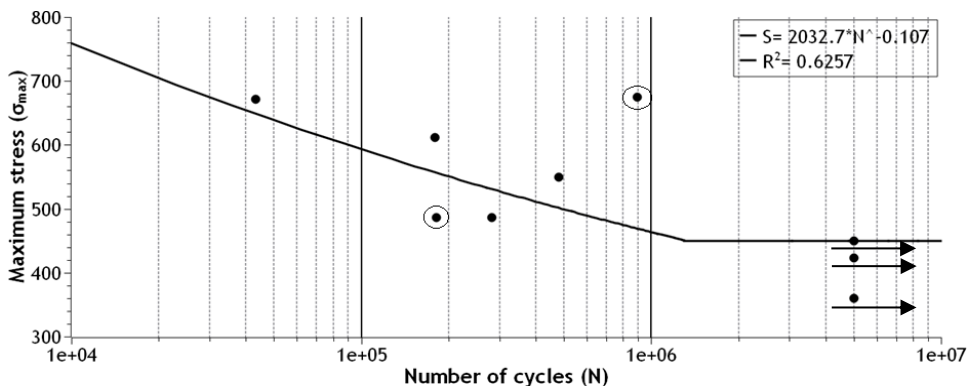
Figure 3: Semi-log S-N diagram for X-build direction specimens

Figure 3 presents a semi-log curve of the maximum stress against the number of load cycles (S-N) of the X-build direction DMLS Ti6Al4V (ELI) specimens, based on the data shown in Table 2.

Linearisation of the curve shown in Figure 3 for the X-build direction specimens was carried out without taking into account the outliers (specimens X-2 and X-4, encircled in the figure). The correlation coefficient (R) of -0.791 indicates a strong inverse linear pattern between  $\sigma_{max}$  and  $\log_{10} N$ , which continues until the knee point of the curve at  $\sigma_{max} = 450$  MPa, where the curve turns horizontal. The horizontal part of the curve represents the fatigue endurance limit, which is estimated from the highest  $\sigma_{max}$  of the run-out specimens indicated by arrows [19].

Specimen X-2 showed a high number of cycles to failure at high loads, whereas specimen X-4 showed a low number of cycles to failure at low loads. These results are converse to expectations, and their fracture surfaces were therefore studied in the SEM in an attempt to identify the causes of this unexpected behaviour. The results are shown in Figures 4 and 5.

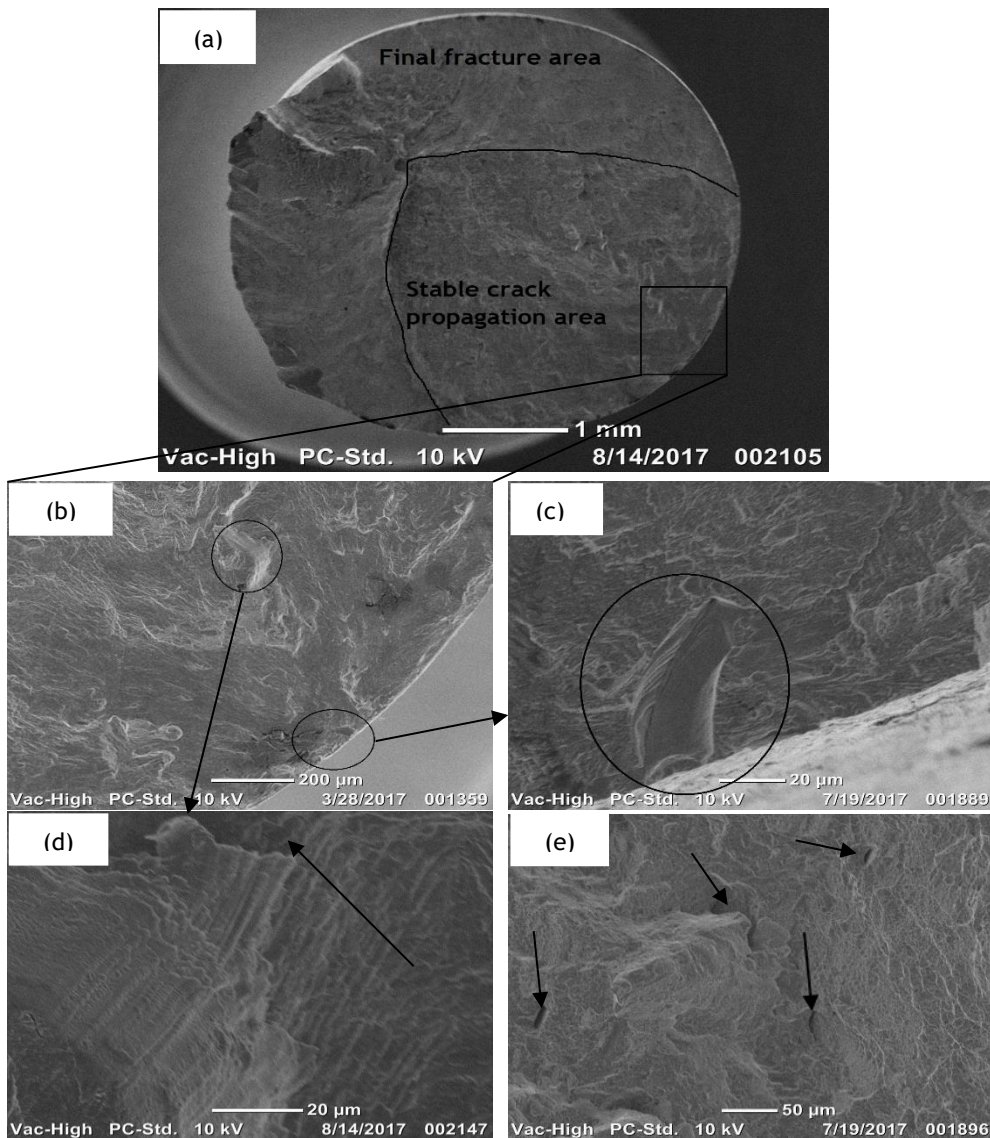
**Figure 4:** (a) Overall fractograph of specimen X-2; (b) a magnified area around the crack initiation site; (c) further magnification of the area around the crack initiation site; (d) high magnification of crack propagation path showing fatigue striations; and (e) a magnified crack propagation area with DMLS process related pores

Figure 4 shows fractographs of specimen X-2, which was cycled at a maximum stress of 675 MPa and fractured after 896,033 cycles.

Fatigue failure of the specimen initiated from the 20  $\mu\text{m}$  wide and 46  $\mu\text{m}$  deep surface pore encircled in Figure 4(c). Fatigue striations shown in Figure 4(d) bow-out from the crack initiation pore in the direction indicated by the arrow in the micrograph. The fatigue striations were magnified from the face of the tear ridge encircled in Figure 4(b). From the overall fractograph in Figure 4(a) it can be seen that the tear ridges run across the entire crack propagation area until the final shear fracture area, indicating a fairly stable crack propagation rate throughout. Across this crack propagation area, internal pores were located and were found to be aligned in the direction of the river ridges, as indicated by arrows in Figure 4(e).

Specimen X-2 showed the mentioned high number of cycles to failure at a high maximum stress load because it had the smallest micro-pore crack initiation site of all the specimens built along the X-build direction. This implies that the stress concentration factor imposed by porosity on this specimen was the lowest. This conclusion is drawn from the theory of fatigue, which states that the majority of the fatigue life of a specimen lies in the crack initiation stage [12, 13].

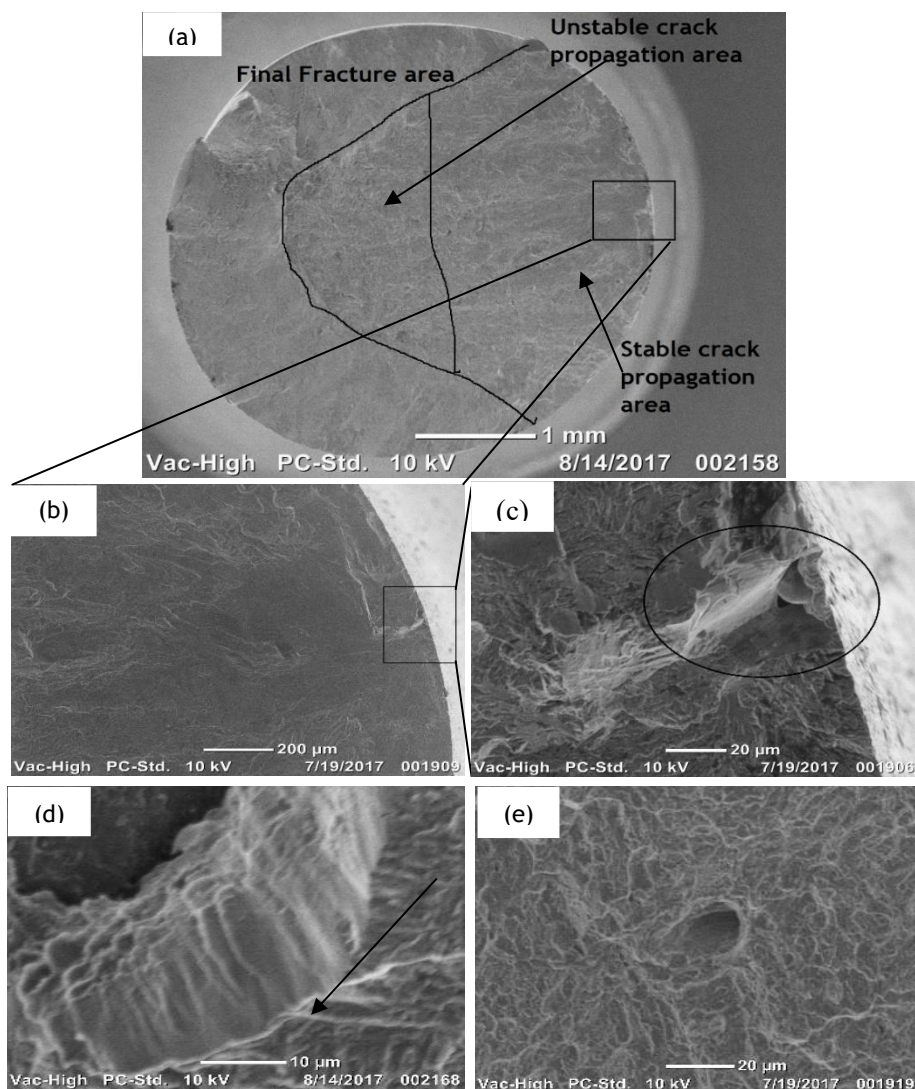
**Figure 5: (a) Overall fractograph of specimen X-4; (b) a magnified area around the crack initiation site; (c) further magnification around the crack initiation site; (d) high magnification of fatigue striations in a stable crack propagation area; (e) micrograph showing shallow dimples in an unstable crack propagation area**

Figure 5 shows fractographs of specimen X-4, which was cycled at maximum stress of 486 MPa and fractured after 181,753 cycles.

Fatigue failure in this specimen initiated from the 40  $\mu\text{m}$  wide and 44  $\mu\text{m}$  deep surface pore encircled in Figure 5(c). The crack propagation area is divided into the stable and unstable crack propagation zones indicated in Figure 5(a). The fatigue striations depicted in Figure 5(d) were found on the face of a tear ridge in the stable crack propagation area and bow-out from the crack initiation pore in a direction indicated by an arrow. Internal micro-pores were located in both crack propagation areas.

The stress concentration factor of the crack initiation pore in this specimen is relatively higher than that in the previous case, and leads to accelerated local plastic deformation that initiates propagation of the crack. The pores located in both the stable and the unstable crack propagation areas provided an easy path for the propagating crack, accelerating its rate of propagation and thus the small number of cycles to failure at a low maximum stress load. The small number of cycles to failure on the fracture surface can also be identified by the coarse striations seen in Figure 5(d), as opposed to the fine striations located on specimen X-2, which endured a high number of cycles to failure.

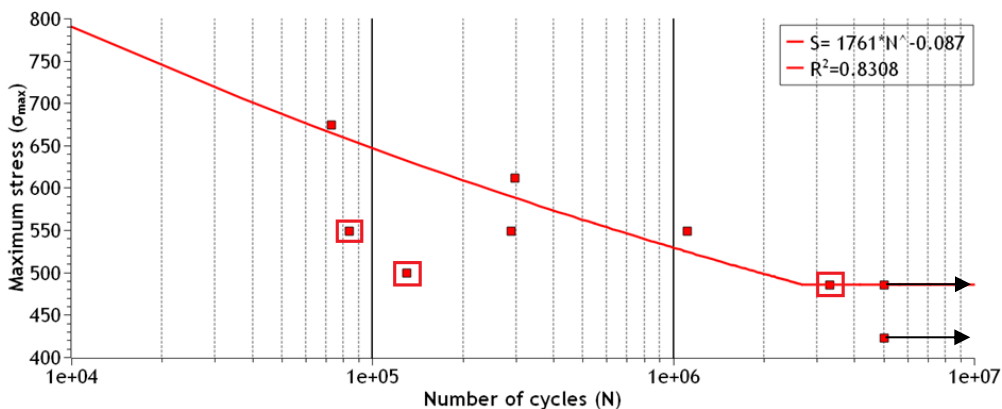
**Figure 6: Semi-log S-N diagram for Y-build direction specimens**

Figure 6 presents a semi-log curve of the maximum stress against the number of load cycles of the Y-build direction DMLS Ti6Al4V (ELI) specimens, based on the data shown in Table 3.

A linear curve was fitted to the data in Table 3, ignoring the outliers Y-14, Y-18 and Y-19, which are indicated by data points enclosed in squares in Figure 6. The data points show a strong inverse linear relationship with a correlation coefficient (R) of -0.9115. The linear curve turns horizontal at  $\sigma_{max} = 486$  MPa, which is the estimated fatigue endurance limit for the highest  $\sigma_{max}$  of the run-out specimens, indicated by arrows in Figure 6.

Specimen Y-14 was excluded because it failed at 3,295,499 cycles while loaded at the estimated fatigue endurance limit. Specimens Y-18 and Y-19 showed exceptionally low numbers of cycles to failure at stress loads that are above the estimated endurance limit. The fracture surfaces of

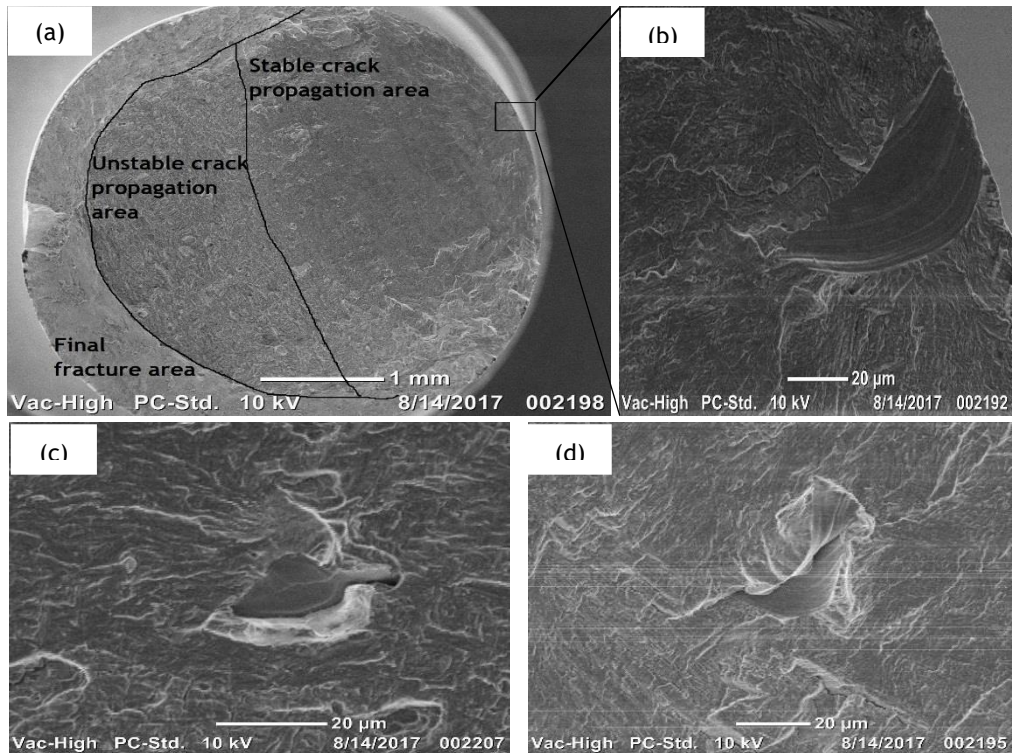
**Figure 7: (a) Overall fractograph of specimen Y-19; (b) high magnification of an area around the crack initiation site; and (c) and (d) high magnification of DMLS process-related internal pores**

Figure 7 shows the fractograph of specimen Y-19, which was cycled at a maximum stress of 500 MPa and fractured after 130,072 cycles.

The fatigue fracture features of specimen Y-19 are similar to those of specimen X-4 (shown in Figure 6). The crack initiated from a  $38\ \mu\text{m}$  wide and  $75\ \mu\text{m}$  deep surface pore shown in Figure 7(b). The crack propagated at a slow rate (stable crack propagation area) across the specimen, as shown in Figures 7(c) and (d). Multiple comparatively smaller pores with reference to the crack initiation pore of similar geometry to those depicted in Figures 7(c) and (d) were located in the slow crack propagation area.

The specimen Y-19 fractured from a relatively large pore initiated crack. However, multiple internal pores located across the stable crack propagation area locally accelerated the stable crack propagation. The increased crack propagation rate is evident from the relatively small stable crack propagation area seen in Figure 7(a). This gave rise to a low number of cycles to failure at the low maximum stress levels prevailing during cyclic loading of this specimen (approaching the endurance limit).

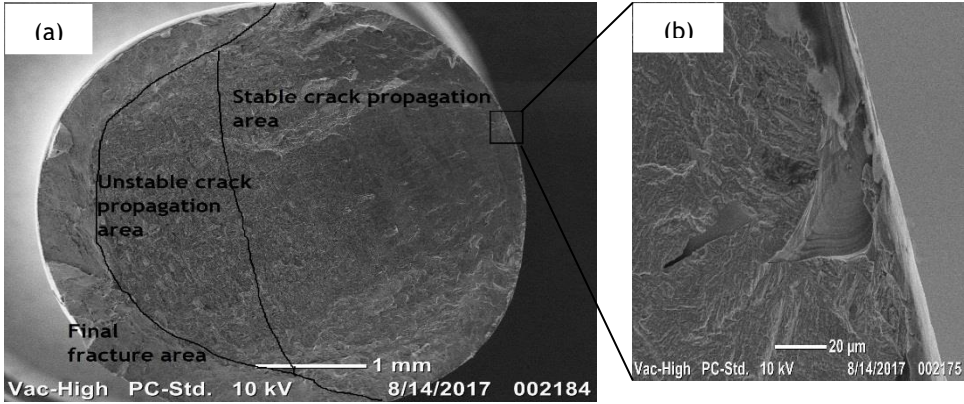
Figure 8: (a) Overall fractograph of specimen X-18; (b) high magnification of crack initiation site

Figure 8 shows the fractographs of specimen Y-18, which was cycled at a maximum stress of 549 MPa and fractured after 83,464 cycles.

The fatigue failure crack of specimen Y-18 initiated from a  $42\ \mu\text{m}$  wide and  $29\ \mu\text{m}$  deep surface pore that is shown in Figure 8(b). The failure surface had fatigue features of the crack initiation site, stable crack propagation, and unstable crack propagation similar to that of specimen X-4 (discussed in section 3.1 above).

The stress concentration factor from the surface pore that initiated the crack for this specimen was lower than those of specimens Y-13 (width = 100  $\mu\text{m}$  and deep = 56  $\mu\text{m}$ ) and Y-16 (width = 67  $\mu\text{m}$  and depth = 42  $\mu\text{m}$ ), which were cycled at the same maximum stress but failed at higher numbers of cycles. A total of eight micro-pores were located on the fracture surface of specimen Y-18, but such numbers of flaws were not found in specimens Y-13 and Y-16. These internal micro-pores are likely to have contributed to the fracture of this specimen at a lower number of cycles than specimens Y-13 and Y-16 for the same maximum stress load. This is because, upon contact of the crack tip with a pore, subsequent merging of the two accelerates the growth of the cracked area towards its critical area (overload area on the specimen).

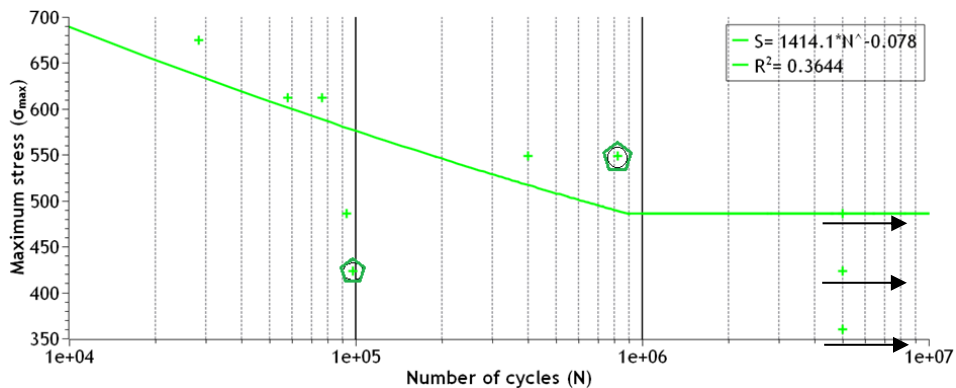
Figure 9: Semi-log S-N diagram for Z-build direction specimens

Figure 9 presents a semi-log curve of the maximum stress against the number of load cycles of the Z-build direction DMLS Ti6Al4V (ELI) specimens, based on the data shown in Table 4.

Linear curve fitting through the fatigue data for these specimens was done without including the fatigue data from specimens Z-25 and Z-29, indicated by data points enclosed in pentagons in Figure 9, because they were considered to be outliers. The correlation coefficient (R) of -0.6037 given by these scattered data points is moderate. The curve forms a knee at 486 MPa, where it turns horizontal, given by the highest  $\sigma_{max}$  of run-out specimens, indicated by arrows in Figure 9.

Specimen Z-25 showed a low number of cycles to failure at relatively low load, whereas specimen Z-29 showed a high number of cycles to failure at high load. The fracture surfaces of these outliers were studied in a SEM to identify the reason for their unexpected behaviour. Their fractographs are shown in Figures 9 and 10.

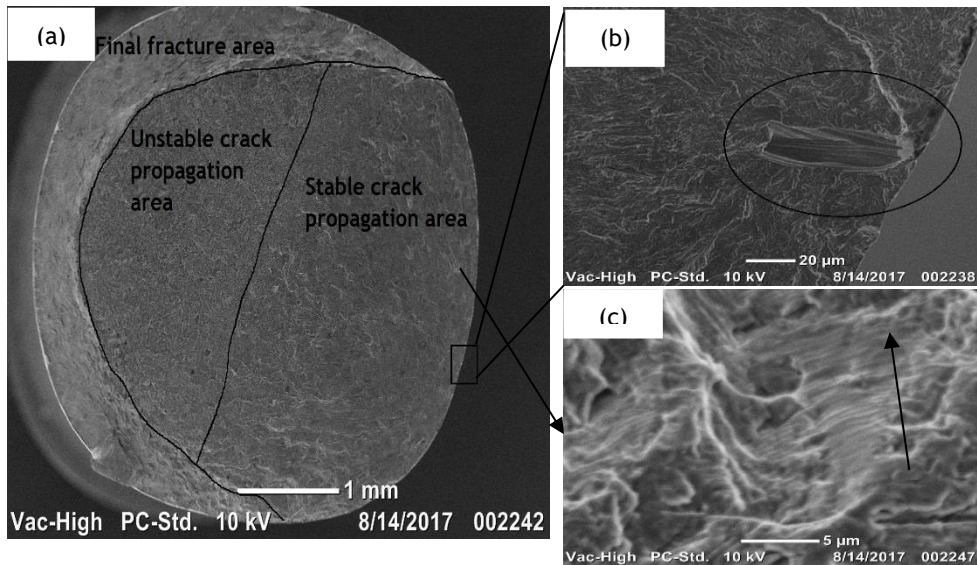
**Figure 9: (a) Overall fractograph of the specimen; (b) high magnification of an area around the crack initiation site; and (c) high magnification on a tear ridge showing fatigue striations**

Figure 9 shows the fractographs of specimen Z-29, which was cycled at a maximum stress of 549 MPa and fractured after 822,565 cycles.

Specimen Z-29 fractured after a relatively high number of cycles at high stress load because the crack initiation was from a very small stress concentration resulting from a 11  $\mu\text{m}$  wide and 57  $\mu\text{m}$  deep sub-surface pore, encircled in Figure 9(b). Fatigue striations were located on the face of a tear ridge and bow-out from the direction of the crack initiation pore, indicated by an arrow in Figure 9(c). This crack initiation pore had the smallest length of all the crack initiation pores for this series of specimens. No other internal pores were located on its fracture surface. Due to the absence of internal pores that would have accelerated the crack tip to the crack's critical length (overload/unstable crack propagation area), specimen Z-29 showed a fairly large area of an unstable crack propagation zone. However, the crack propagation area was similar to that of specimen X-4, which is divided into an area of stable crack propagation and an unstable crack propagation area, depicted in Figure 5.

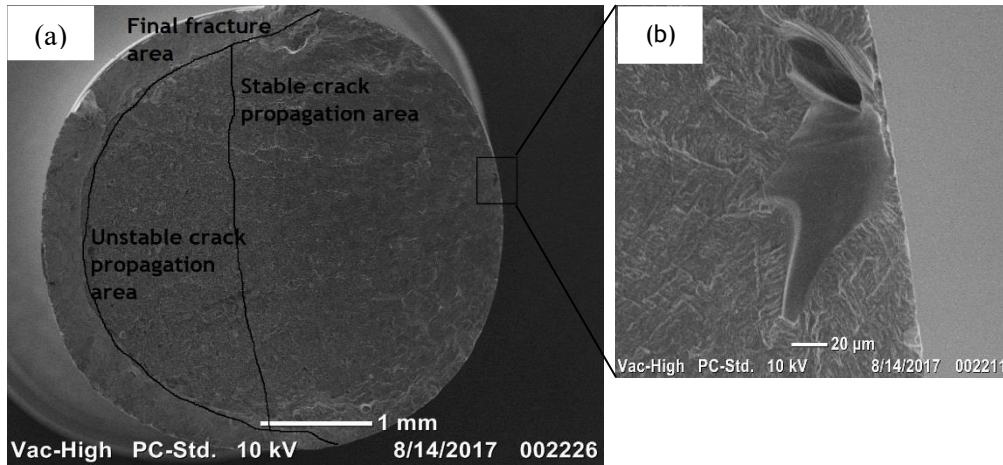
Figure 10: (a) Overall fractograph of specimen Z-25; (b) high magnification of an area around the crack initiation

Figure 10 shows the micrographs of specimen Z-25, which was cycled at a maximum stress of 423 MPa and fractured after 97,743 cycles

Fatigue crack fracture of specimen Z-25 initiated from a 120 $\mu\text{m}$  wide and 68  $\mu\text{m}$  deep pore, which was the longest length of pore to initiate a crack in Z-build direction specimens. A couple of smaller micro-pores were located on both the slow and the fast crack propagation areas. Contact of the crack tip with a pore locally accelerates the crack propagation rate towards the overload monotonic fracture zone. The stable crack propagation area covered the major part of the fatigue crack propagation area. Thus the relatively large crack initiation pore, together with the internal pores, resulted in specimen Z-25 fracturing after only a small number of cycles at a low stress.

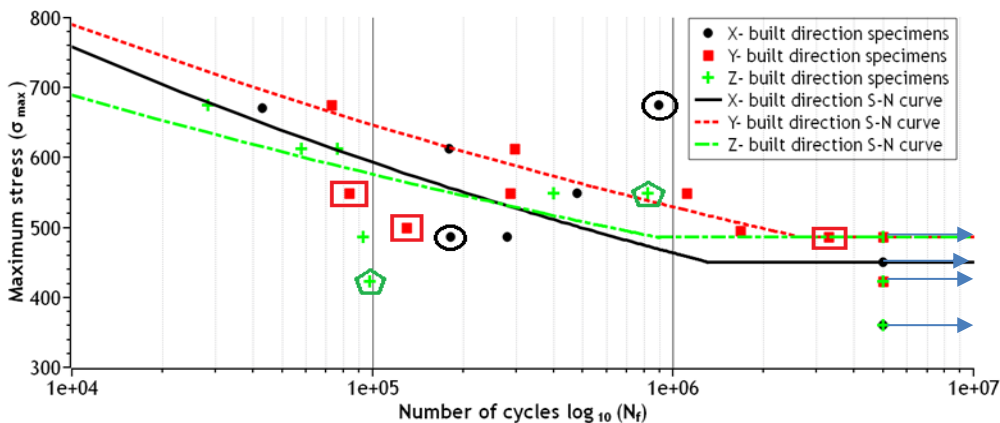
Figure 11: Fatigue S-N curves of DMLS Ti6Al4V (ELI) specimens built in the X-, Y- and Z-build directions

In Figure 11 the different S-N curves for the as-built X-, Y-, and Z-build direction Ti6Al4V (ELI) specimens are presented.

Table 5 presents the estimated fatigue endurance limits for the as-built X-, Y- and Z-build direction DMLS Ti6Al4V (ELI) specimens, derived from the curves in Figure 11.
