TENSILE AND HIGH CYCLE FATIGUE PROPERTIES OF ANNEALED Ti6Al4V (ELI) SPECIMENS PRODUCED BY DIRECT METAL LASER SINTERING

Presented at the 19th Annual International RAPDASA conference, held from 7 to 9 November 2018 in Johannesburg, South Africa

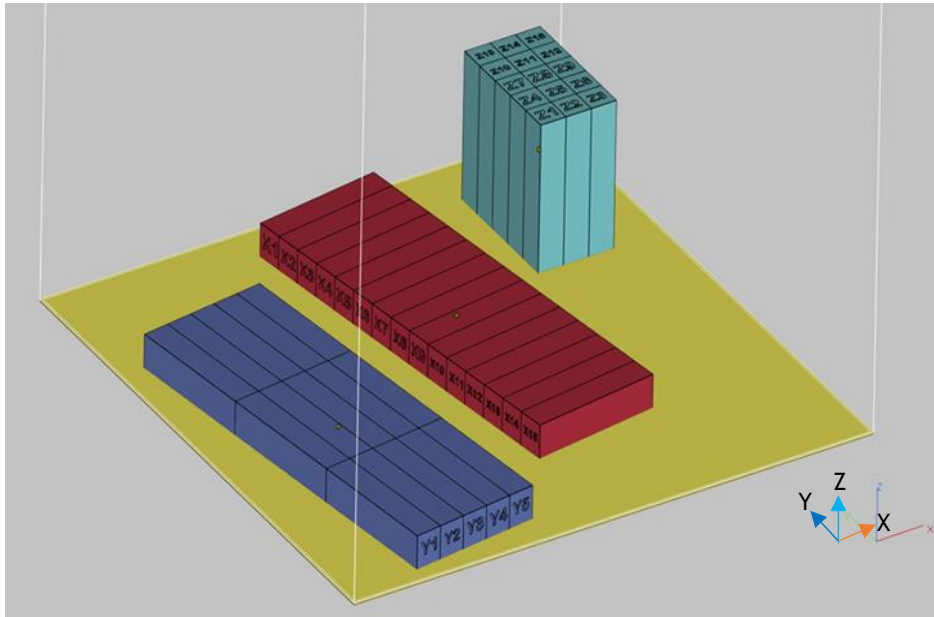
Figure 1 shows a CAD model of 45 square bars on a DMLS build platform, representing the three mutually orthogonal DMLS building directions.

Figure 1: Illustration of the build directions of the bars from which the tensile and fatigue specimens were machined

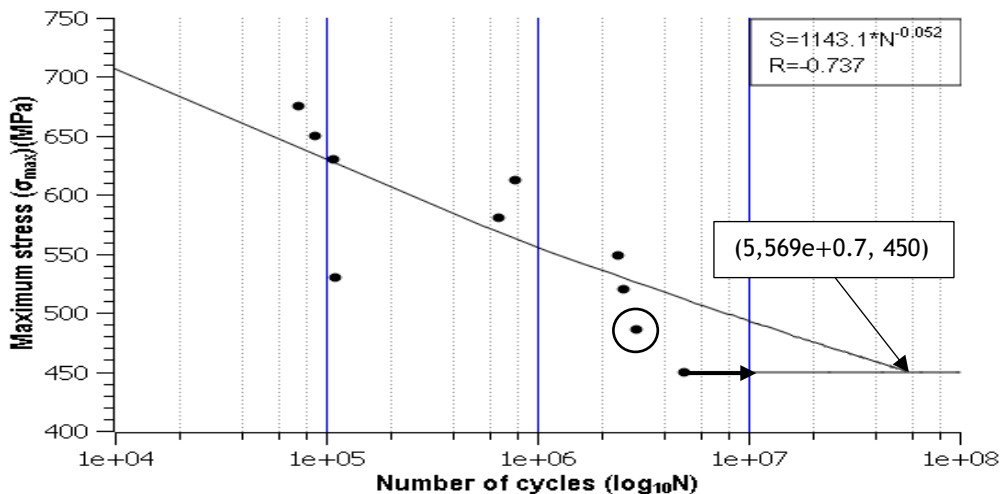
Figure 2 presents a semi-log curve of the maximum stress against the number of load cycles (S-N) for the X-build direction HTA DMLS Ti6Al4V (ELI) specimens.

Figure 2: Semi-log S-N diagram for HTA DMLS Ti6Al4V (ELI) X-build direction specimens

The semi-log S-N plot in Figure 2 shows the typical curve profile of steels and titanium alloys of linearly decreasing magnitude of the maximum stress (σ_{max}) with the natural logarithm to base 10 of the life ($\log_{10} N$), up to a point defining the endurance limit. It is noted that the endurance limit in this case was higher than the set run-out of 5,000,000 cycles, when testing was stopped and used to estimate the endurance limit, as run-out is typically selected according to the expected application [15]. The fatigue endurance limit of the X-build direction DMLS HTA Ti6Al4V (ELI) specimens, according to the semi-log S-N plot in this figure, is seen to be $\sigma_{max} = 450 \text{ MPa}$, which was found for specimen X-7, indicated by an arrow in Figure 2 [5]. This endurance limit is at a level of 48 per cent with reference to the average UTS of the X-build direction HTA specimens presented in Table 3.

Specimen X-11, circled in Figure 2, was not included in the linearisation of the fractured specimens, as it fractured from the grip ends and was regarded as an outlier. The correlation coefficient (R) of -0.737 indicates a strong inverse linear relationship between σ_{max} and $\log_{10}N$ for the X-build direction DMLS HTA Ti6Al4V (ELI) specimens. Extrapolation of the linearised curve for the fractured specimens and the horizontal curve for the fatigue endurance limit at $\sigma_{max} = 450$ MPa resulted in an estimate of the knee point at 55,690,000 load cycles, as indicated in Figure 2. This knee point estimate is higher than the estimated value for the as-built X-build direction DMLS Ti6Al4V (ELI) specimens in reference [16] and assumed here during testing. This implies an increase in the number of load cycles to failure of DMLS Ti6Al4V (ELI) specimens after the application of the HTA process [16].

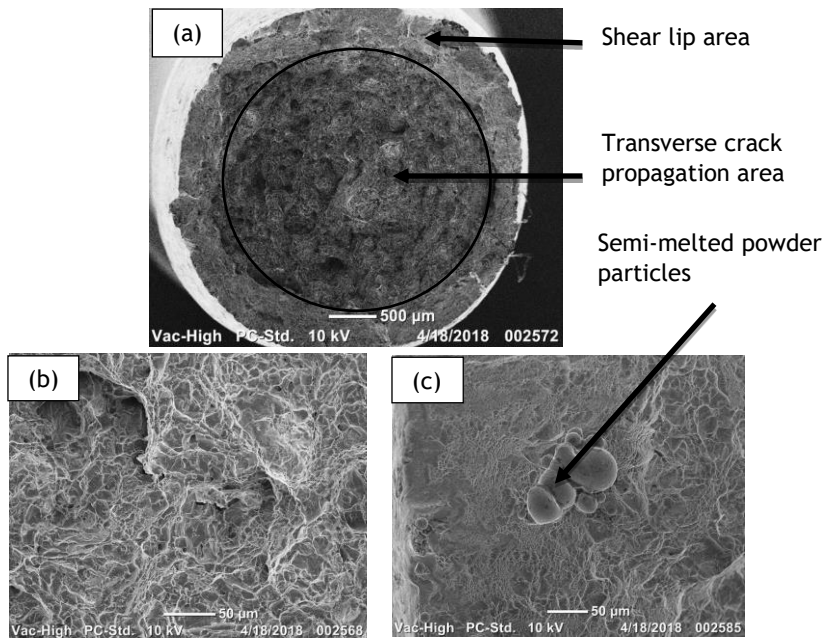
Figure 5 shows scanning electron microscope (SEM) secondary electron imaging (SEI) fractographs of the fractured HTA DMLS Ti6Al4V (ELI) tensile test specimens Z-2.

Figure 5: (a) Overall fractograph of specimen Z-2; (b) high magnification of the transverse crack propagation area; and (c) high magnification of the shear lip areas around semi-melted powder particles

The HTA DMLS Ti6Al4V (ELI) fractured tensile specimens built along the X-, Y-, and Z-directions had the same fracture features. The fractographs from specimen Z-2 in Figure 5 were selected to discuss the fracture modes of the specimens built in the three mutually orthogonal DMLS build directions.

The fracture features indicate ductile fracture modes. This conclusion is drawn from the observed cup-and-cone features with pronounced necking around the fracture zone of the specimens, such as the one shown in Figure 5(a). These are indicative of transverse propagation of cracks in the central flat areas of the fracture surface (circled in Figure 5(a)) and shear propagation of cracks inclined to the longitudinal direction of the specimens in the cup-and-cone lip areas on the periphery of the specimens [17]. On increasing the magnification of the areas of transverse propagation of cracks, the fibrous nature of the fracture surfaces became more pronounced, indicating a ductile fracture at a microscale [16]. A further increase in magnification in these areas of transverse propagation of cracks revealed the presence of dimples, as seen in Figure 5(b) (magnifications from the circled areas in Figure 5(a)). The dimples are characteristic of nucleation and coalescence of voids, which is typical of ductile fracture [18, 19]. Similar dimples are also seen on the shear lip areas, shown in Figure 5(c).

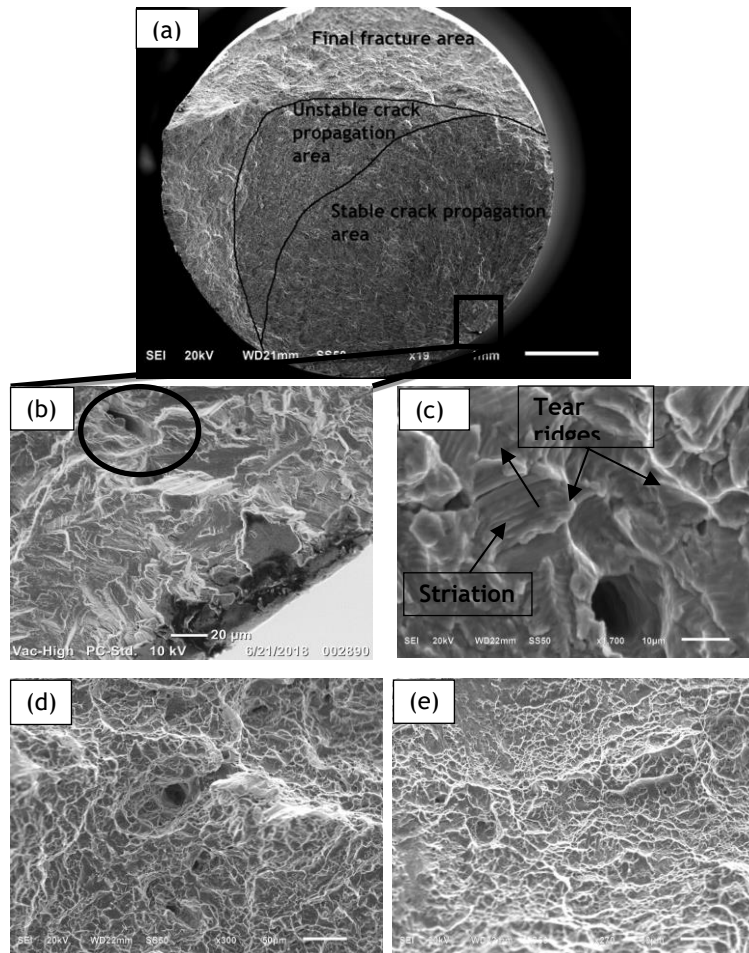
Figure 6 shows SEM SEI fractographs of specimen X-12, which was cycled at a maximum stress of 520 MPa and fractured after 2,580,515 cycles.

Figure 6: (a) Overall fractograph of specimen X-12; (b) a magnified area around the crack initiation site with the crack initiation pore circled; (c) high magnification of the stable crack propagation area showing fatigue striations, with the arrow indicating the direction of the fatigue crack propagation; (d) high magnification of the unstable crack propagation area showing a shallow dimpled fracture mode; and (e) high magnification of the shear lip area showing a dimpled fracture mode

The fractographs and the micro-CT scan images for the fracture planes of the specimens X-12, Y-12, and Z-12 are shown in Figures 6, 8, and 10 and Figures 7, 9, and 11 respectively. The ΔK values calculated for the crack initiation pores of these specimens increased in the order of specimens X-12, Y-12, and Z-12, following their projected areas that increased in the same order. Specimen X-12 showed the highest number of load cycles to failure of these specimens because its crack initiated from a pore with the lowest value of ΔK , which implies that the rate of plastic deformation at its pore tip was the lowest of the three specimens. The value of ΔK of the crack initiation pore in specimen Z-12 was lower than that of specimen Y-12, but it failed after a higher number of load cycles than specimen Y-12 [11, 12]. The shorter specimen life of specimen Y-12 is attributed to a high distribution of internal pores around the crack initiation pore, as shown in Figure 9, which implies an accelerated local crack propagation through merging of the crack tip with these pores in the early stage of crack propagation.

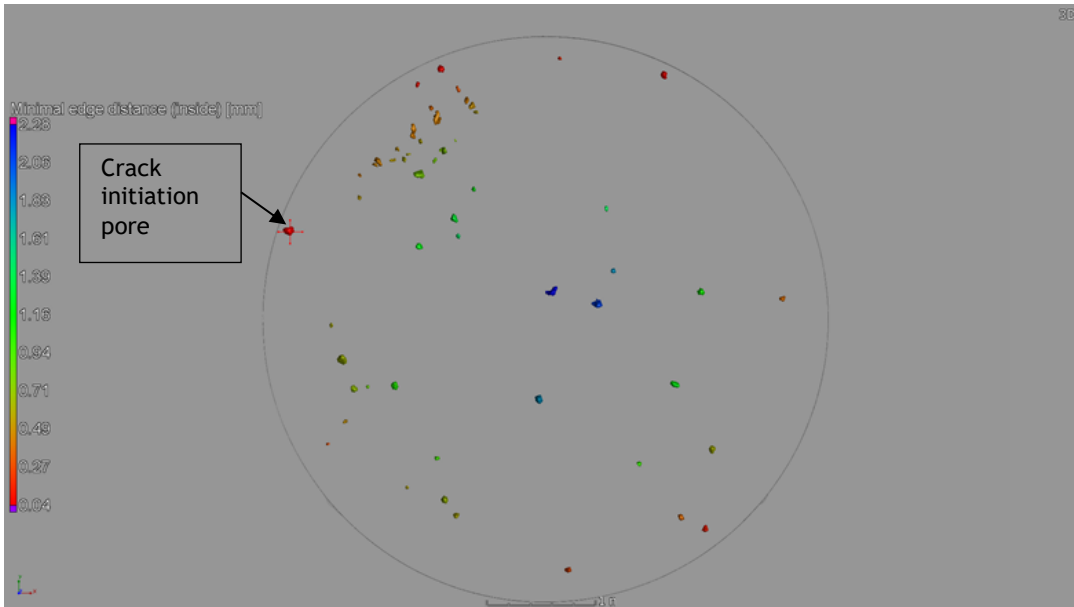
Figure 7 shows the micro-CT scan image on the fracture plane of specimen X-12, with the crack initiation pore indicated by a cross. This crack initiation pore had an area of 0.00433 mm², resulting in a value of $\Delta K = 4.37 \text{ MPa m}^{0.5}$.

Figure 7: Micro-CT scan image on the fracture plane of specimen X-12, with the crack initiation pore marked with a cross (see online version for colour)

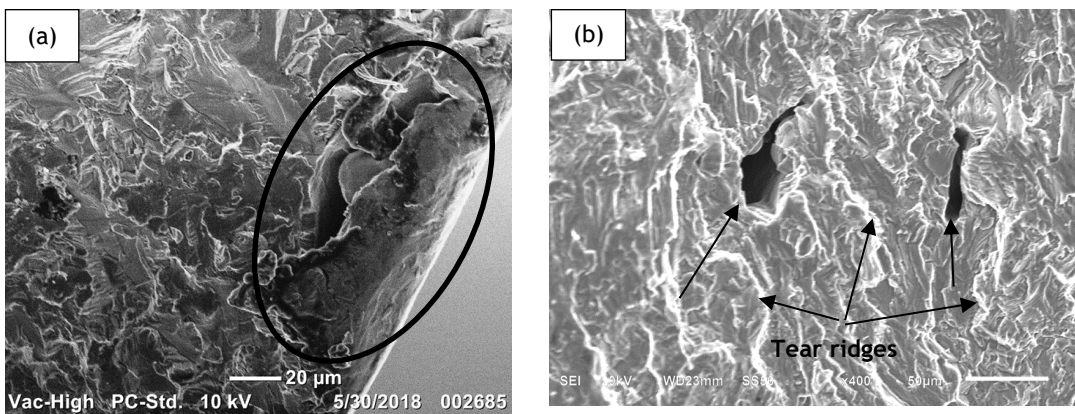
Figure 8 shows SEM SEI fractographs of specimen Y-12, which was cycled at a maximum stress of 520 MPa and fractured after 125,582 cycles.

Figure 8: (a) High magnification fractograph of specimen Y-12 around the crack initiation pore, with the crack initiation pore circled; and (b) a high magnification of the stable crack propagation area around internal DMLS process-related pores indicated by arrows

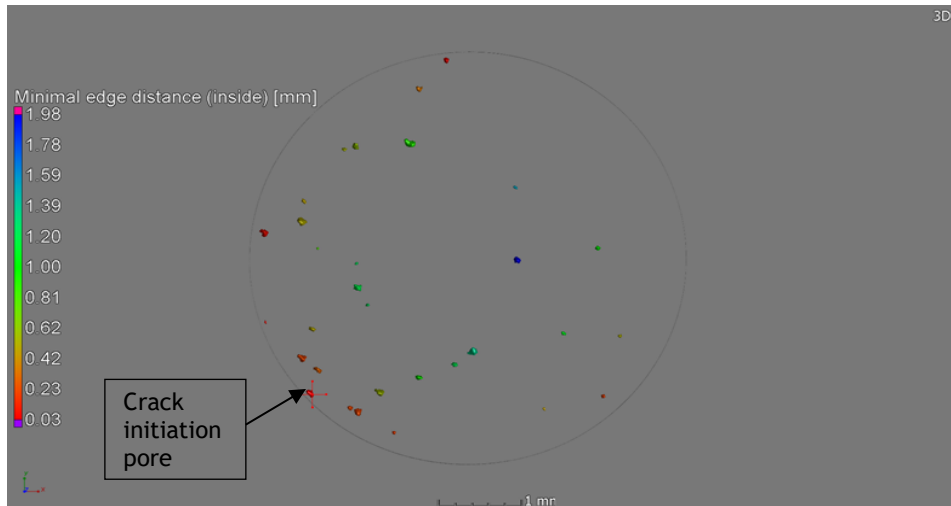
Figure 9 shows the micro-CT scan image on the fracture plane of specimen Y-12, with the crack initiation pore indicated by a cross. This crack initiation pore had an area of 0.00748 mm², resulting in a value of $\Delta K = 5.01 \text{ MPa m}^{0.5}$.

Figure 9: Micro-CT scan image on the fracture plane of specimen Y-12, with the crack initiation pore marked with a cross (see online version for colour)

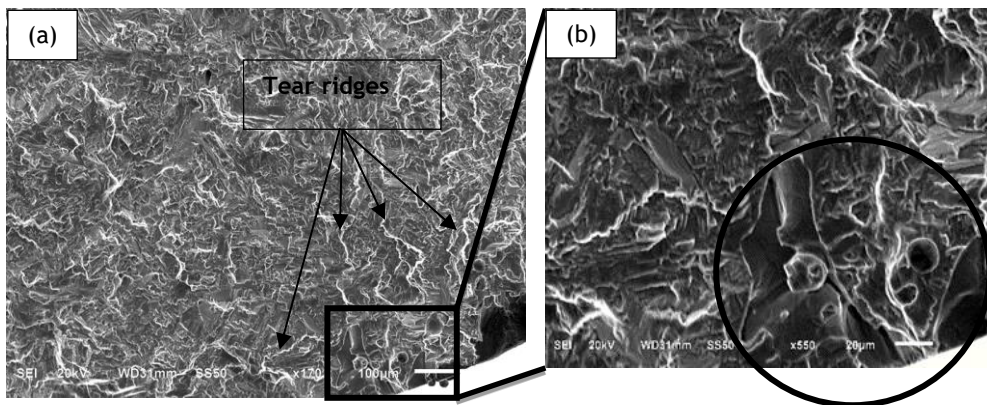
Figure 10 shows SEM SEI fractographs of specimen Z-12, which was cycled at a maximum stress of 520 MPa and fractured after 156,868 cycles.

Figure 10: A magnified fractograph of specimen Z-12 around the crack initiation pore; and (b) high magnification around the site, with the crack initiation pore circled

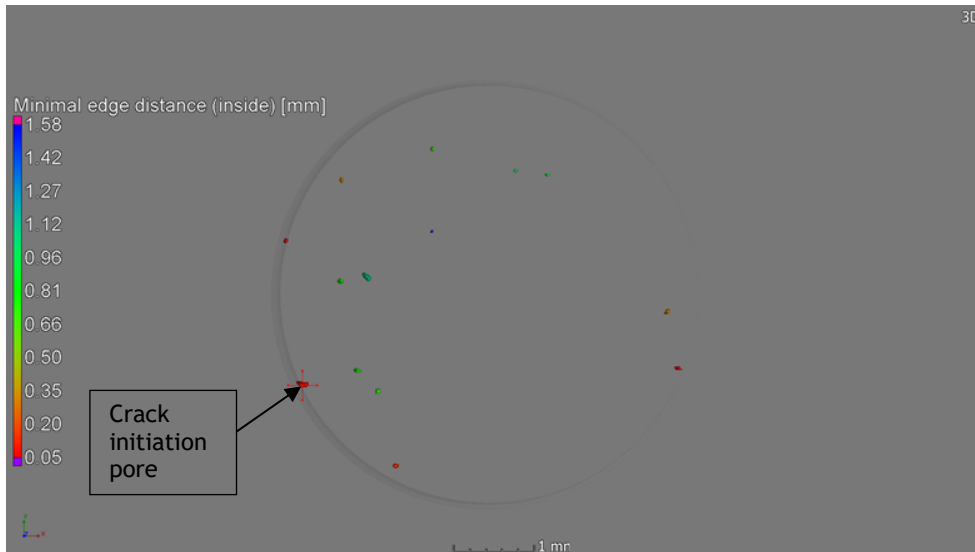
Figure 11 shows the micro-CT scan image on the fracture plane of specimen Z-12, with the crack initiation pore indicated by a cross. This crack initiation pore had an area of 0.01553 mm^2 , resulting in a value of $\Delta K = 6.02 \text{ MPa m}^{0.5}$.

Figure 11: Micro-CT scan image on the fracture plane of specimen Z-12, with the crack initiation pore marked with a cross (see online version for colour)
